Commission of Inquiry into the Collapse of a Portion of the de la Concorde Overpass

October 3, 2006 - October 15, 2007

REPORT

**Commission d'enquête
sur le viaduc
de la Concorde**

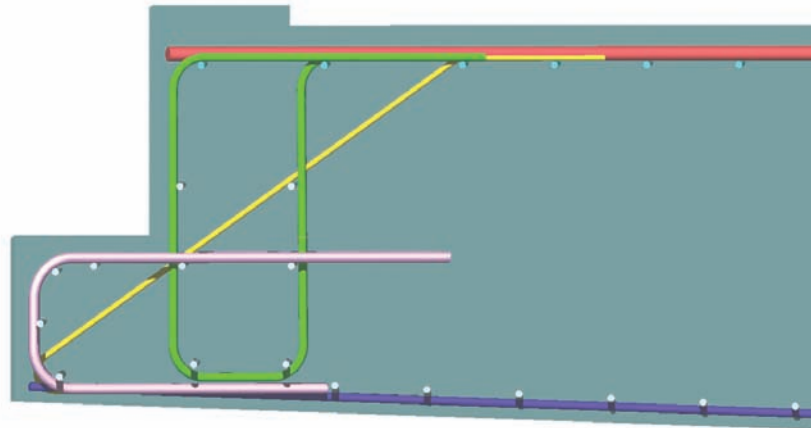
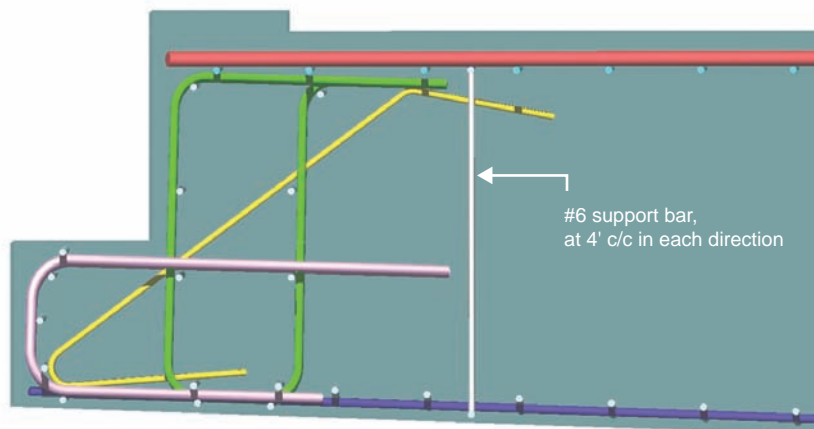
Figure 2.10 Layout of the Chair Bearing Support Reinforcements *As Designed* and *As Built* in the Cantiliver of the East Abutment

As the reader will note in Chapters 5 and 6, this installation of reinforcing bars contrary to the plans and specifications had important consequences. To assess its full significance, we must also appreciate the forces and stresses exerted on the concrete, which the reinforcing bars should normally allow it to withstand. This is the subject of the next section.

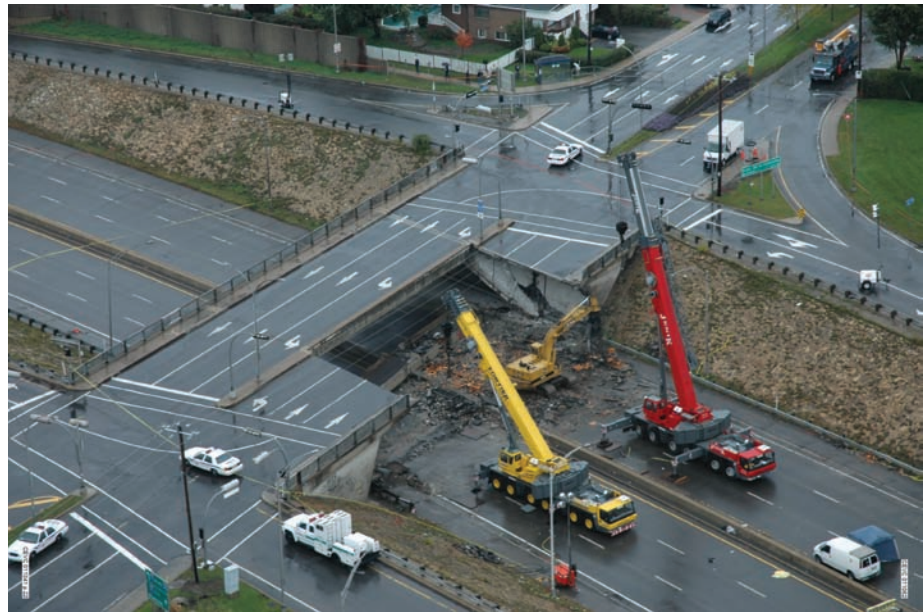
On Saturday, September 30, 2006, around 12:30 p.m., the south deck of the overpass located at the intersection of Boulevard de la Concorde and Autoroute 19 in Laval collapsed. The sudden fall of this overpass caused the deaths of five people and injured six others. The following pages describe the circumstances of the collapse, as presented in evidence by the main witnesses of this event or by the persons who participated in the first response, in securing the site and in the deployment of safety measures. A detailed chronology of the highlights appears in the summary of the police response.²

Figure 3.1 Collapsed Portion of the de la Concorde Overpass³

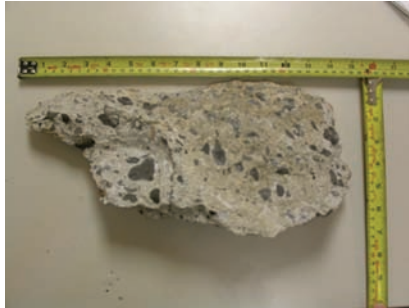
Figure 3.2 Concrete Block Picked up by Mr. Bonin

For Mr. Bonin, this concrete chunk constitutes [TRANSLATION] “*ordinary debris*”,¹⁶ similar to those he picks up near various structures, about once a month according to his recollection. Traffic was normal on the overpass. He did not notice any particular jumping, slowing of traffic, noise or vibration during the 15 minutes he spent on the scene, and no other concrete chunk fell. The top of the guardrail was at the same level on both sides of the expansion joint.

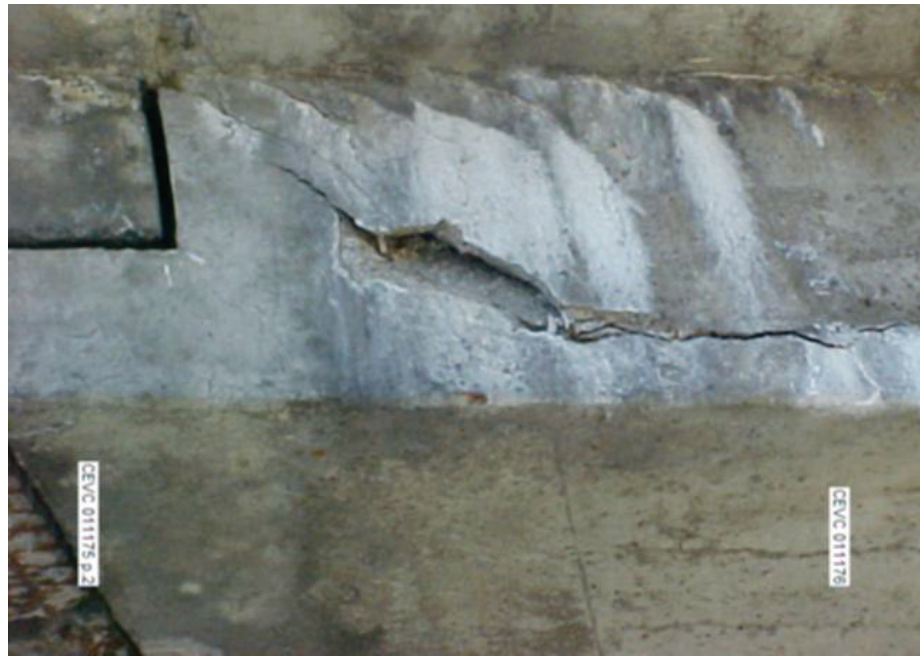
Figure 3.3 Hole and Crack in the East Abutment, photographed by Mr. Bonin between 11:45 a.m. and 12:00 p.m., September 30, 2006.

However, Mr. Bonin filled out an anomaly report in which he wrote [TRANSLATION] *“To be inspected PC”*¹⁸ (a written adaptation of a common French expression meaning a definite emergency). This is the first time that he had asked for an overpass to be inspected and in his testimony before the Commission, he specified that he wanted to be sure that the inspection [TRANSLATION] *“would be done the following Monday”*.¹⁹

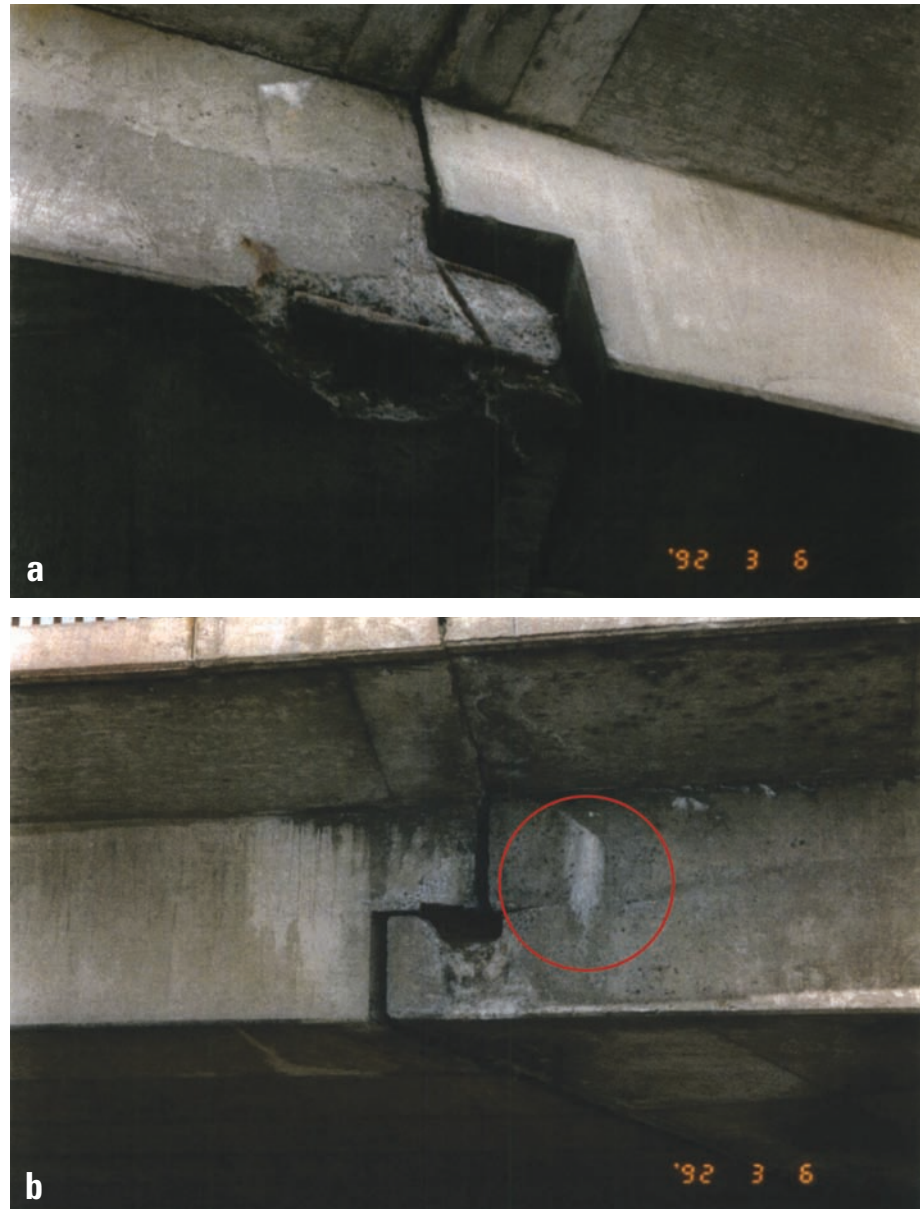
Figure 4.3 Concrete degradation on the east abutment of the de la Concorde overpass in 1992

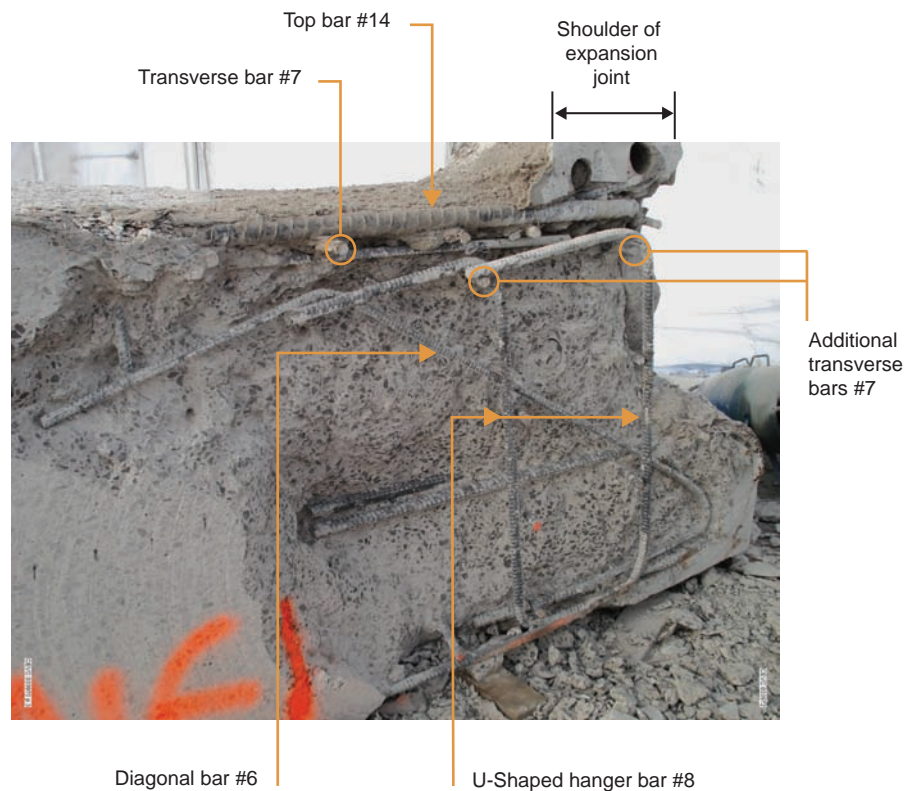
The U-shaped hanger bars were not installed as shown on the drawings (Figure 5.5). The upright parts of the hangers were not installed vertically. Furthermore, at the top of these bars, the hooks designed to transfer the load to the No. 14 bars were inclined, instead of being on the same plane and parallel to these bars, as intended by the designer. On the east side, the hooks are under the No. 14 bars, contributing to the creation of a zone of weakness.

Figure 5.5 Faulty placement of reinforcing bars in the bearing support area²⁸

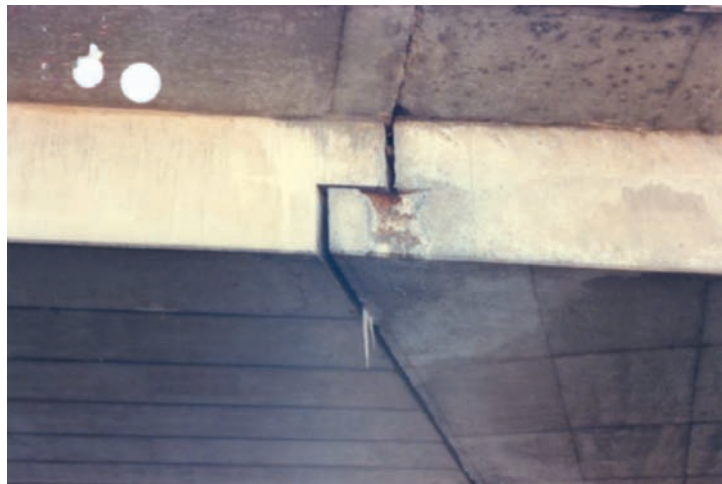
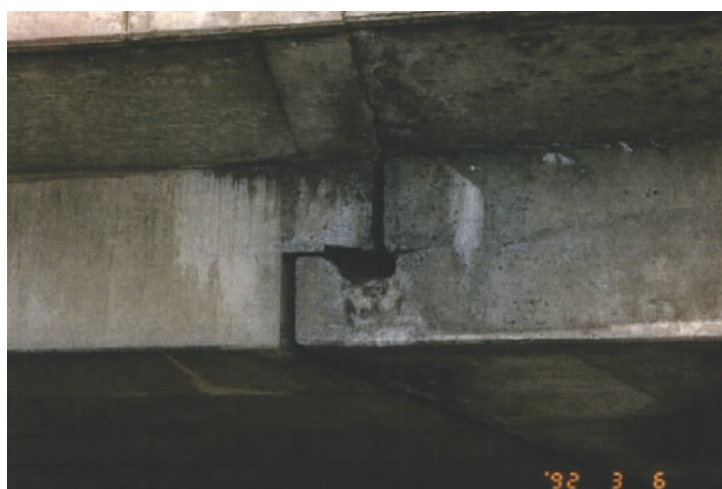
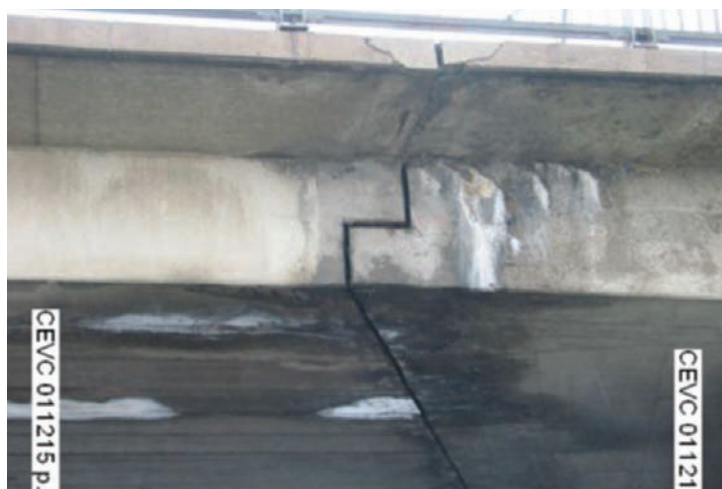
1992, it was impossible for him to appreciate the evolution of the problems, such as depicted in the photographic montage of Exhibit COM-68D (Figure 5.6).

Figure 5.6 Views of the east cantilever, from the south side of the de la Concorde overpass, showing the evolution of cracks in the bearing support area⁷⁸

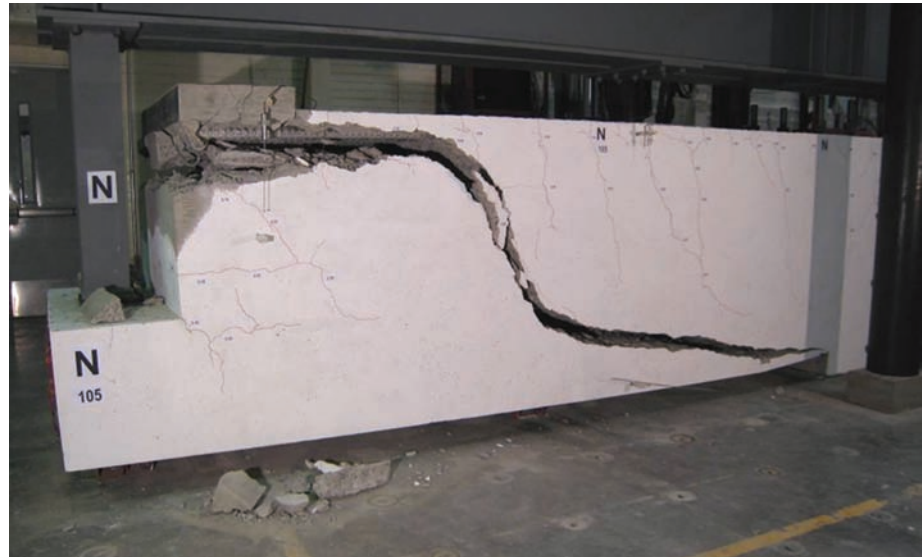
overpass (see Figure 5.7). In the upper part of the slab, a horizontal crack extends up to the end of the hooks of the hangers and diagonal bars. The crack then suddenly becomes inclined as a shear crack, traveling downwards through the slab, then finally turns horizontal along the lower rebars, splitting the cantilever up to the junction with the inclined wall.

Figure 5.7 Failure of the “as-built” cantilever during the laboratory loading tests at McGill University⁹⁰

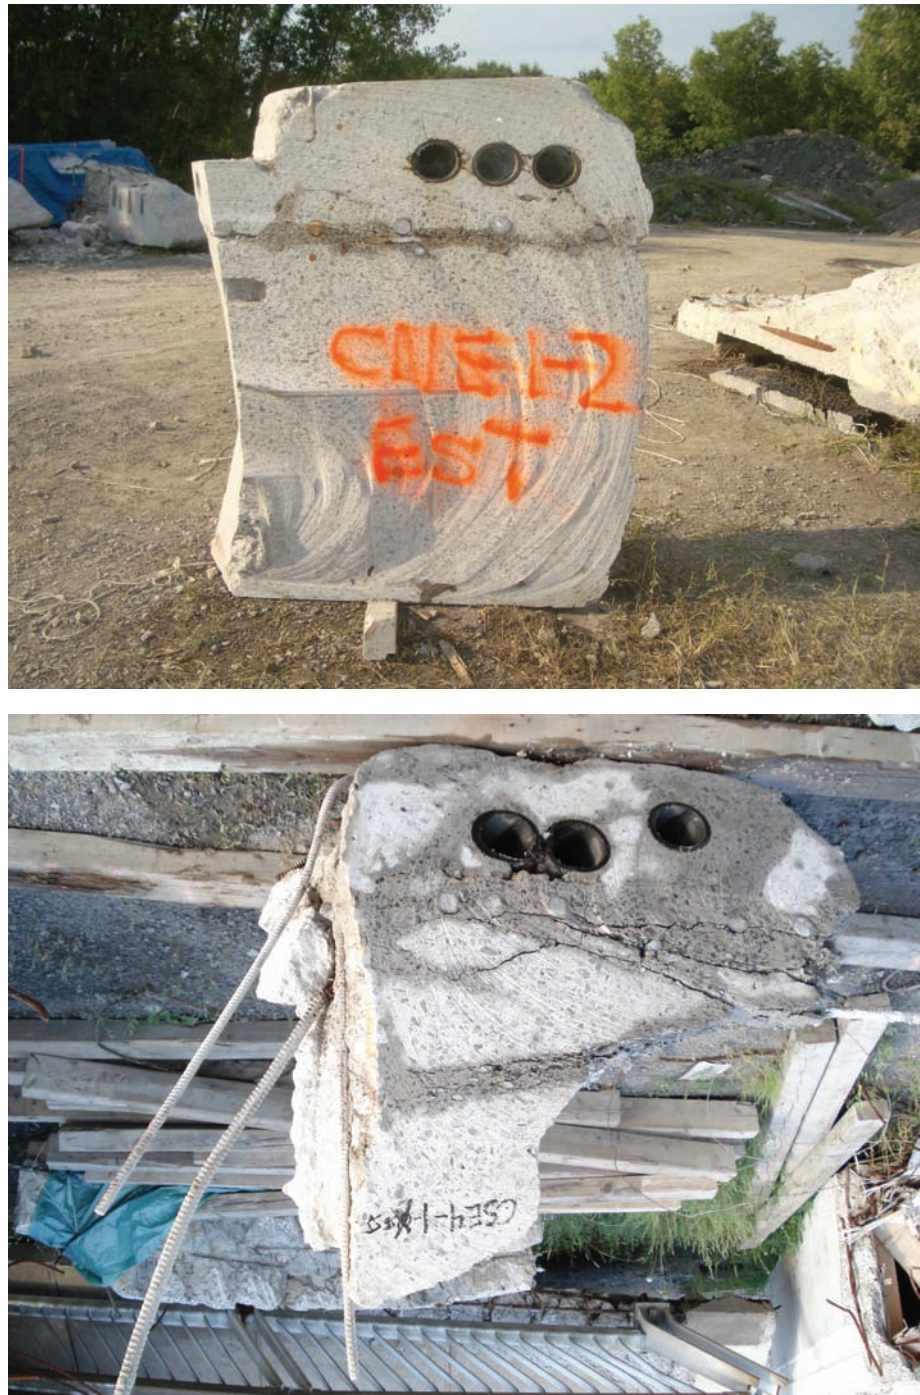
Observations made on the slices taken from block CNE1 from the northeast abutment, showed cracks of the same nature as those seen on the southeast side (Figure 5.8) and that this portion, although less loaded because of the skew in the structure, was liable to collapse at some point in time.

Figure 5.8 Transverse partial cuts of the east abutment performed during the additional dissection operations of August 2007 showing the northeast corner (top) and southeast corner (bottom)¹⁰⁵

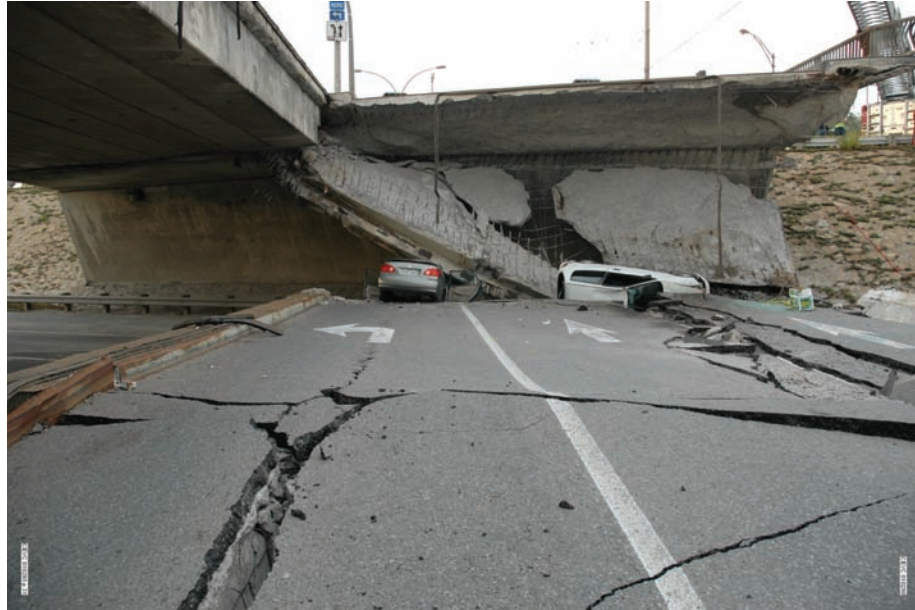
The overpass collapsed due to a shear failure in the south part of the east abutment's cantilever. The beam seat, or corbel, was not involved; this section remained attached to the lower portion of the thick slab following the collapse. The failure occurred in the core of the thick slab.

Figure 6.2 Front view of the east abutment shortly after the collapse, on September 30, 2006²

The upper part of the cantilever remained intact, hanging over Autoroute 19, whereas the lower part pivoted towards the ground, breaking into three large blocks and a number of smaller pieces (Figure 6.2). The three main pieces that separated from the bottom of the cantilever remained attached to the top of the abutment, held by the longitudinal rebars in the bottom of the slab and also partially by the transverse bars in the beam seat near the center of the abutment.

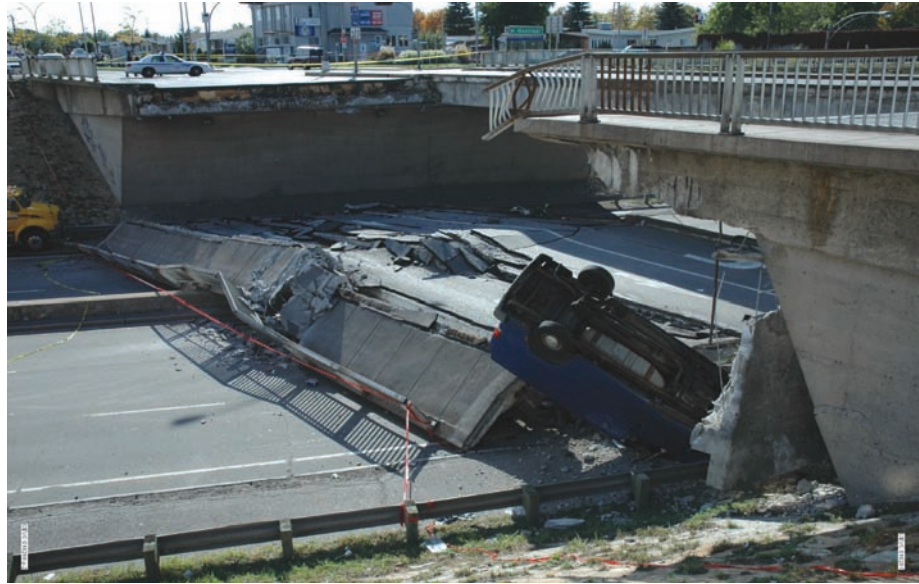
Figure 6.3 View looking to the west of the collapsed overpass, from the east abutment, on September 30, 2006³

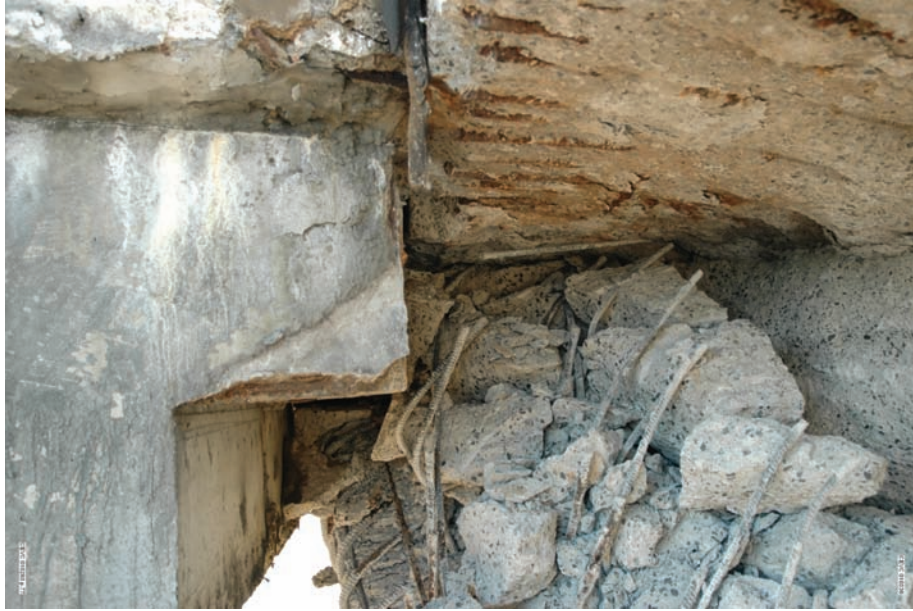
Towards the center of the cantilever slab, shear stresses gradually decrease as one moves away from the southeast corner, where the loads on the supports are more concentrated. The failure of the thick slab stops at the center of the abutment, at a point where the available resistance is sufficient to halt the splitting. The photograph in Figure 6.6 shows many U-shaped hangers severed at the root of the hooks, which indicates that these hangers did possess some anchoring capacity.

Figure 6.6 Photograph of the area of the corbel, towards the center of the abutment, where the slab stopped splitting.⁸

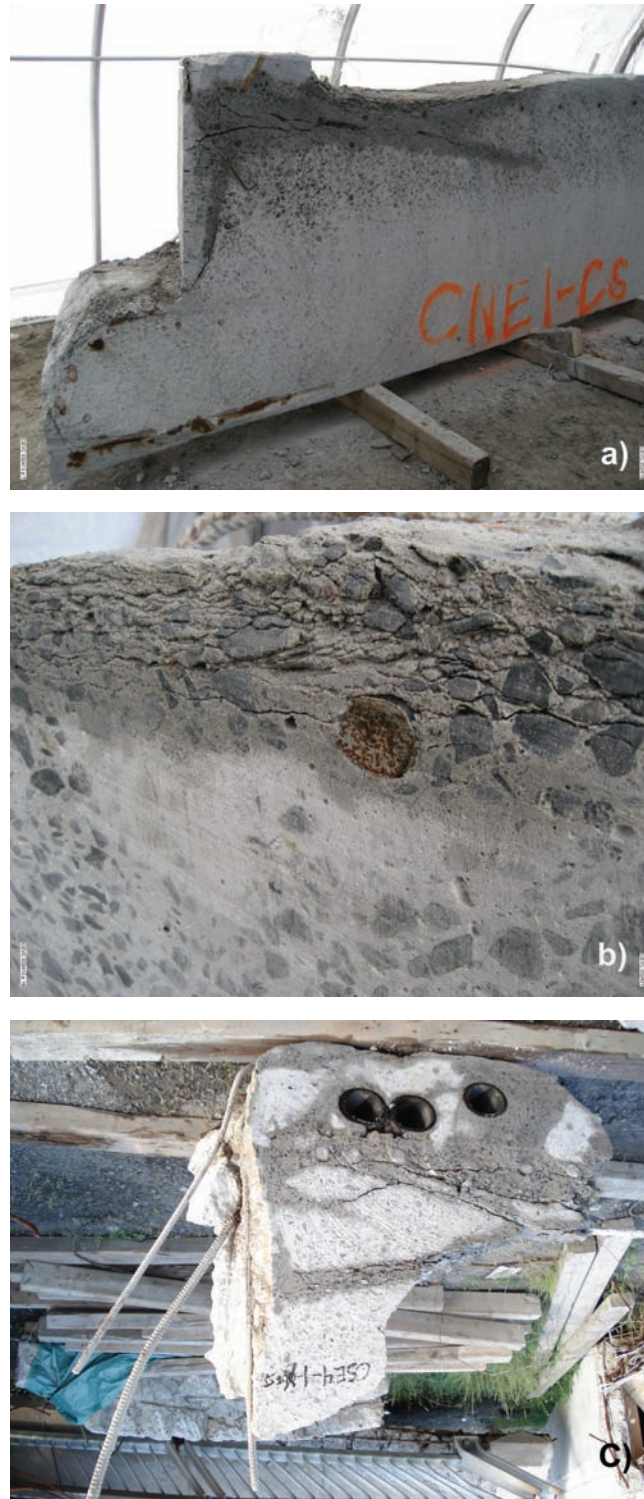
Figure 6.7 Picture of pieces of the east abutment :
 a) Longitudinal section of the non-collapsed part of the slab
 b) Flaking concrete in the upper part of a collapsed piece
 c) Transversal section of the upper corner of the east abutment, on the collapsed side¹³
