Commission of Inquiry into the Collapse of a Portion of the de la Concorde Overpass

October 3, 2006 - October 15, 2007

REPORT

**Commission d'enquête
sur le viaduc
de la Concorde**

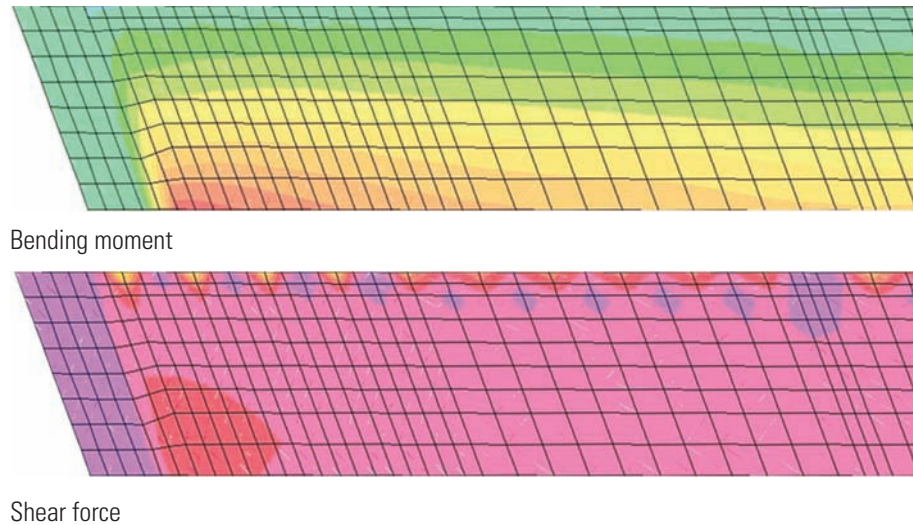
Figure 5.4 Distribution of the bending moment and the shear force in the cantilever of the de la Concorde overpass under dead load, showing the concentration of stresses due to the skew¹²

Mr. Dupaul states that the code allowed for a shear stress of up to 70 psi before any shear reinforcement was required.⁴³ The maximum shear stress calculated for the thick slab of the de la Concorde overpass abutments was 60 psi. However, the presence of a skew in the geometry of the abutment slabs creates stresses in the south corner of the east abutment and the north corner of the west abutment that exceed the average stresses calculated by Mr. Dupaul⁴⁴ (see Figure 2.1). In his calculations, he accounted for the effect of the skew by considering the total length of the cantilever measured along the axis of the bridge, and not perpendicular to the supporting wall. However, the finite element analysis tools that are commonly used today, but were not available in 1969, show that the forces are more concentrated than was indicated by Mr. Dupaul’s calculations and that these calculated stresses exceed the stresses allowed by CSA-S6-1966.⁴⁵

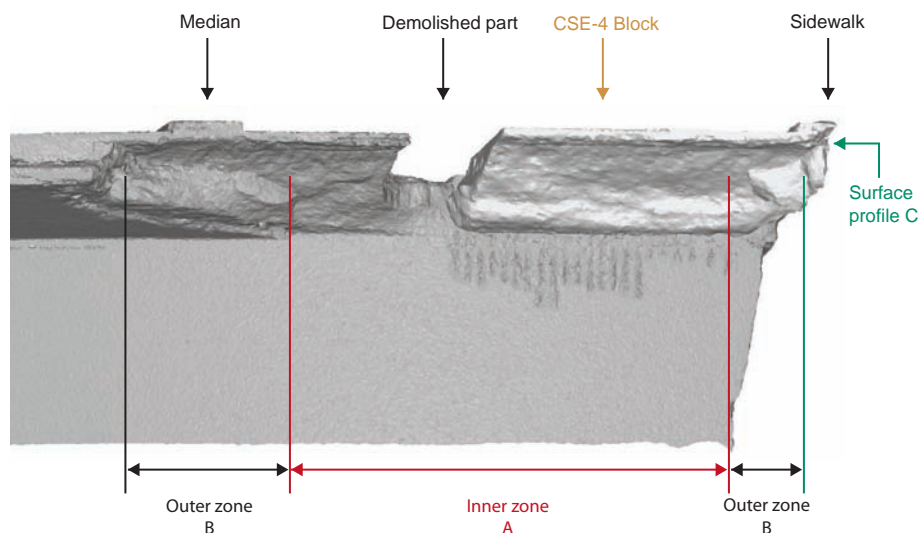
Figure 6.4 Three-dimensional reconstruction of the failure surface from survey report

Figure 6.4 represents the east abutment, seen from the front, generated by the three-dimensional reconstruction of a survey done with laser scanning by the Commission's experts. The viewpoint is similar to the viewpoint in Figure 6.2, except that the suspended lower blocks and the north superstructure have been removed. The gray sections were surveyed at the collapse site following removal of block CSE-4 (taken to the Belgrand Street site for measurement and analysis) and the partial dismantling necessary to its removal (a dismantled section, to the left of block CSE-4, is visible on Figure 6.5). The results of a similar survey were presented during the testimony of one of the experts, Professor Bruno Massicotte.⁵

Finally, on the exterior south face of the abutment, the profile of the failure surface is even more abrupt, and a small vertical slice of concrete remained attached to the abutment (as can also be seen on Figure 6.1 b). The failure surface, in this case, follows profile C.

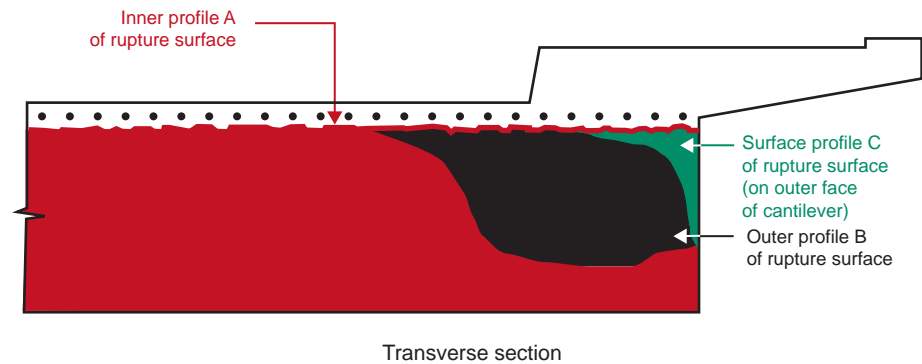
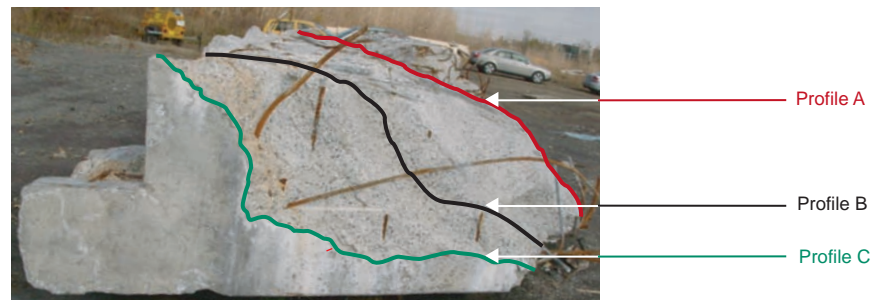
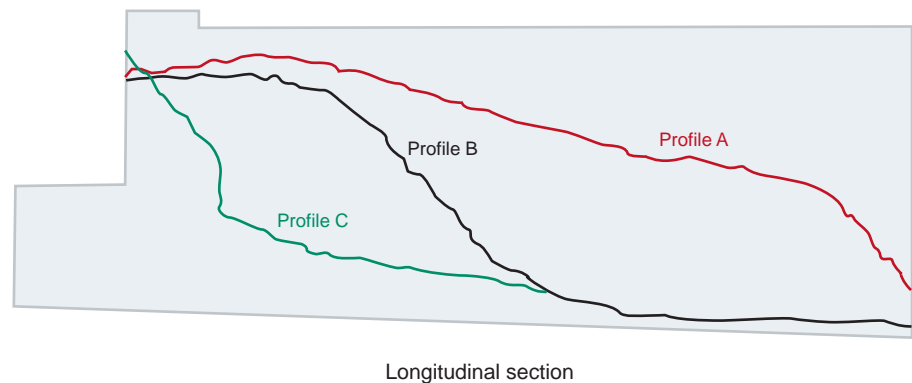
Figure 6.5 Schematic elevation of the cantilever of the east abutment, showing profiles of the failure surfaces.⁶

The three profiles of the three-dimensional failure surface are also schematically shown on the views in Figure 6.5. The picture of exhibit CSE3, detached from the overpass, included in Figure 6.5, clearly shows the contours of these three profiles.

According to the Commission's experts, the failure profiles A and B are quite similar to those obtained through theoretical and experimental studies.⁷ Theoretical resistances calculated for both profiles are almost identical. The presence of surface reinforcement on the exterior south face adds to the shear strength, which explains why the path of the surface failure plane is even more abrupt (profile C). The vertical surface reinforcement bars are also visible, protruding under the concrete, in the picture in Figure 6.1 b)
